HIGH END RESORT, JAMAICA

INTRODUCTION

THE TRIAL

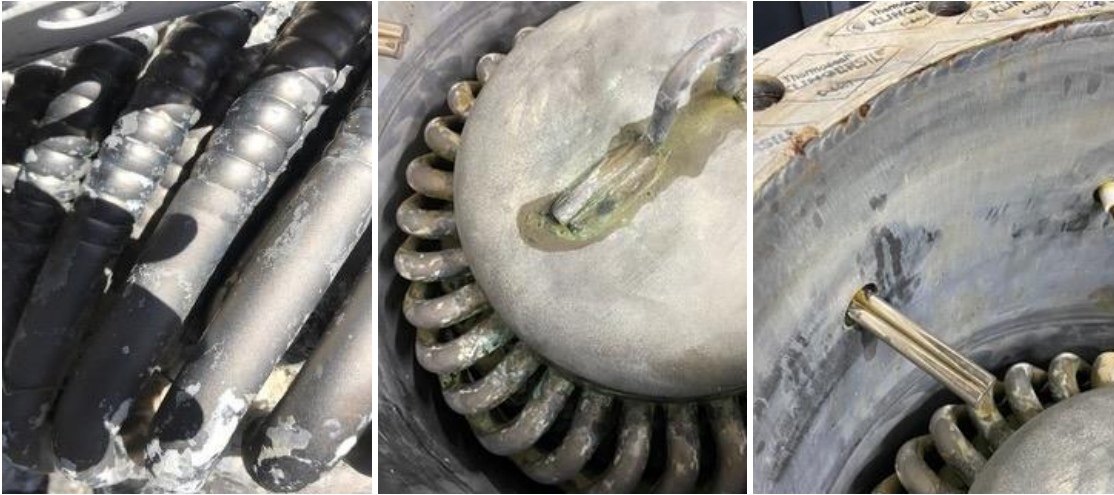
The images above show the heater core after 3 months of the trial. Following the trial no removal for cleaning was necessary, only visual inspection and re-sealing.

The heater core tubes were scaling up to a lump of hard scale after one month, necessitating removal for cleaning every few months. This was very problematic as the heater core was 5 foot long and required an overhead crane to remove it.

Innovation Energy of Jamaica installed one *HydroFLOW*® C150 on the heater supply head between heaters 2 and 3.

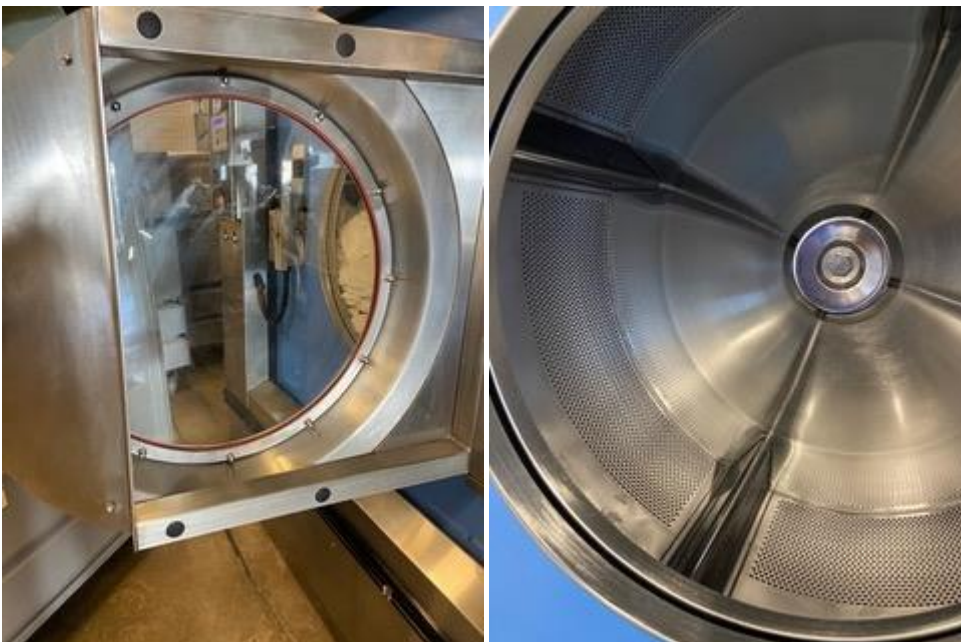
The images above show the results on the washing machine windows and internals after 5 months. The windows are no longer caked with scale and the internals remain

clear.

The washer windows of the 6 large washing machines (located 200m from the heaters) would be caked with scale so the inspection could not be reliably carried out. There were also problems with the associated piping and valves which required monthly servicing.
